## **2011 Operations, Maintenance, and Monitoring Report**

### **Barataria Bay Waterway West Side Shoreline Protection (BA-23)**

State Project Number BA-23  
Priority Project List 4

October 2011  
Jefferson Parish

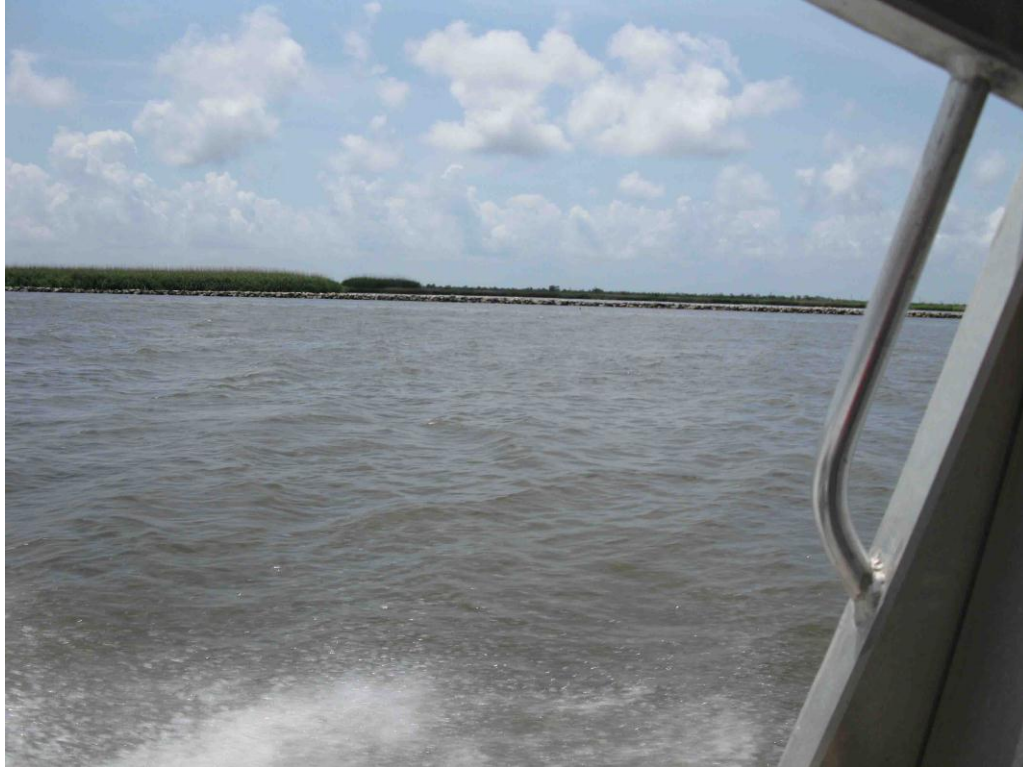
The rock structure appeared to be in good condition at the time of the inspection (Photo #1). There are some sections of settlement, but the structure is still functioning as designed. These sections will continue to be monitored for maintenance needs.

Photo 1. Rock structure. Note low spot on left.

- Continue to check the water control structure during operational procedures.
- Continue to observe rock structure for settlement.
- Repair stop logs and clean slots.

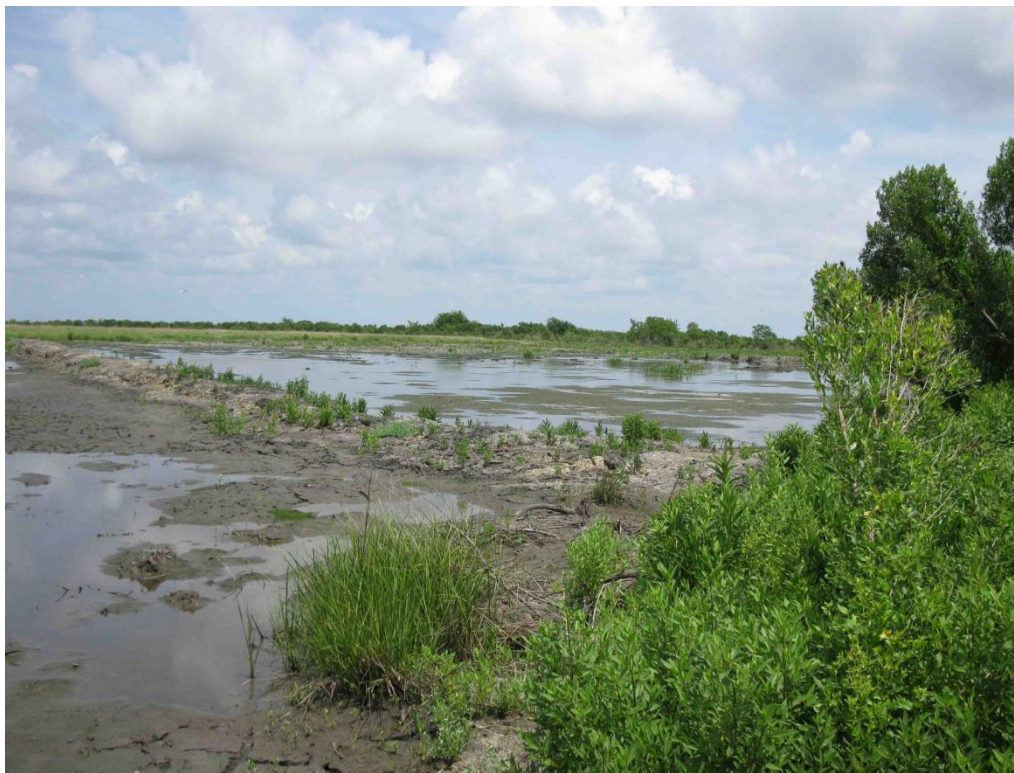
The structure was opened for the first time since the oil spill on March 23, 2011. Everything is still in good condition. Some of the stop logs need repairs and the slots need to be cleaned, but no major repairs are required at this time. The landowner has stated that the test oil and gas well that was drilled was successful and a more permanent well structure will be placed at the mouth of the canal, to one side. The access dredging for the well disturbed little of the 2007 maintenance marsh creation inside the channel. The marsh created within the project as part of the well access dredging appears to be a little low in elevation in spots, but appears healthy overall (Photo #2).

Photo 2. Beneficial use marsh creation using material from oil and gas well access channel.
